## The antiseismic rehabilitation of Marchesale Castle at San Giuliano di Puglia

Maurizio Indirli, Riccardo Cami and Bruno Carpani  
*ENEA & GLIS, Bologna & Brasimone, Italy*

**ABSTRACT:** After the earthquake (October 31<sup>st</sup>, 2002) which struck Molise Region (Italy), an ENEA team has been collaborating to the reconstruction of the town of San Giuliano di Puglia. Many buildings suffered severe damage or partial collapse, including important Masonry Cultural Heritage Structures (MCUHESs). This paper specifically deals with the rehabilitation of the notable Marchesale Castle, in the framework of the ENEA scientific advice given to the Office of the Public Works Ministry. ENEA reviewed in detail the rehabilitation project (entrusted, as other works, to private consultants), suggesting some remedial actions.

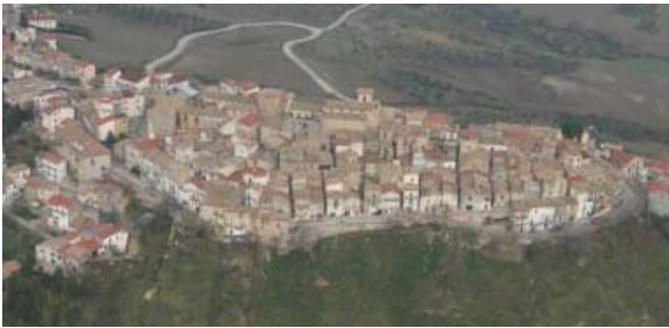
Figure 1. View of the San Giuliano historical center.

The medieval center (Fig. 1), interesting from an historical and architectural point of view, was deeply investigated; in spite of the low local amplification, it presented partial collapses and a medium-severe damage; only a few houses were ready for reuse. Also the more notable MCUHESs (including Marchesale Castle, Fig. 2) suffered heavy damage. All the area was in general characterized by high vulnerability and the most usual collapse mechanisms were the wall failure with typical cross cracks, but also out-of-plane overturning (Indirli et al. 2004a, b).

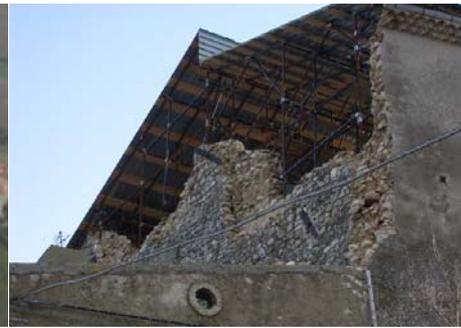
Figure 2. Damage to Marchesale Castle.

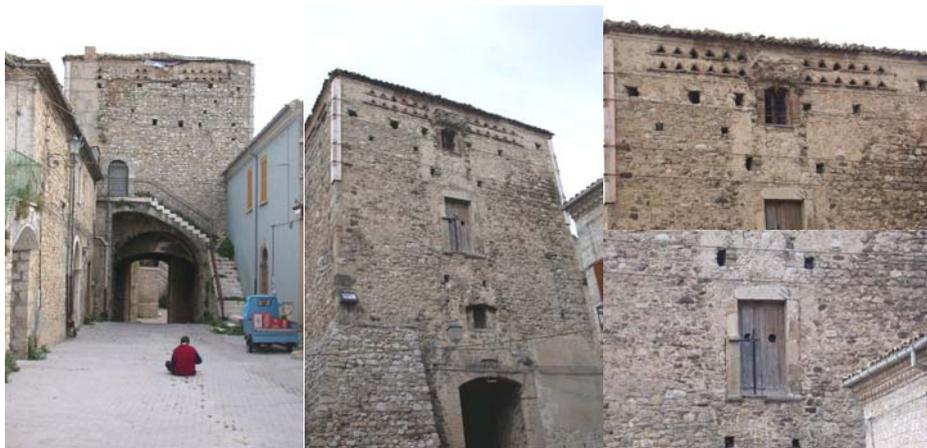
Figure 4. The old Castle Tower.

variously sized river pebbles and brick insertions), likewise the majority of the castle walls. In the tower front views it is still possible to identify pretty genuine architectonic evidences, the so called “*buche pontaise*” (small holes used to provide supplemental defense wooden scaffoldings) and the twice-line triangular pigeon houses located under the roof (Fig. 6). Other aspects are: generally deteriorated mortar courses, plaster traces, brick fillings (old openings and masonry past rehabilitation). After the seismic event the tower free top was tied up with steel cables (in order to avoid overturning collapse) and covered by a steel sheet.

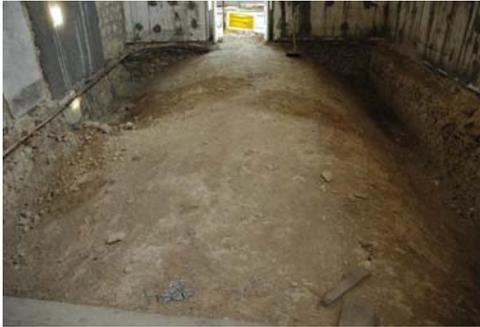
Figure 5. Some vaults details.

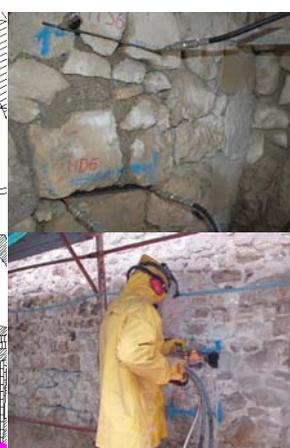
Figure 8. Flat jack tests.

The single flat jack test allows to evaluate the in-situ stress level of the masonry, measuring the stress relaxation due to a perpendicular cut to the wall surface. A thin flat jack is placed inside the cut and the pressure is gradually increased. The double flat jack test can be used to evaluate the masonry deformability characteristic. In this case, a second cut is made (parallel to the first one) and a second jack is inserted. At least two tests (Fig. 8) have been performed on each structural block, and the old tower has been investigated with particular accuracy. In presence of thick walls, tests have been performed on each external curtain. More than twenty single and double flat jack tests have been carried out. Local compression ( $1.0\sim 4.0\text{ kg/cm}^2$ ) and Elasticity Modulus ( $2000\sim 3500\text{ MPa}$ ), have been measured. The compressive resistance can be estimated around a value of  $15.0\sim 20.0\text{ kg/cm}^2$ .

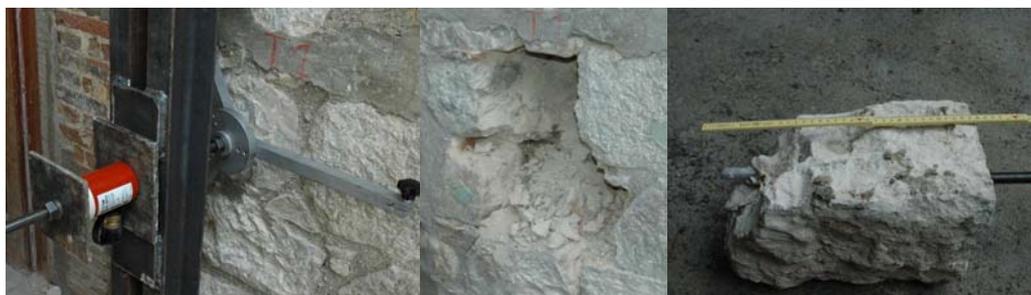
Figure 9. Shear pull out tests.

The shear pull out test (Fig. 9) consists in the insertion of a tensile element (usually a steel bar) into a larger borehole. If used on different masonry portions, it aims to investigate the sliding behavior of the walls, identifying a local shear value ( $\tau_{loc}$ ) “marking” the wall out-of-plane mechanism. These tests generally have been done in the same positions of the flat jack tests, in order to correlate masonry sliding properties with local axial compression (experimental range of  $\tau_{loc}$  values:  $2.0\sim 3.5\text{ kg/cm}^2$ ).

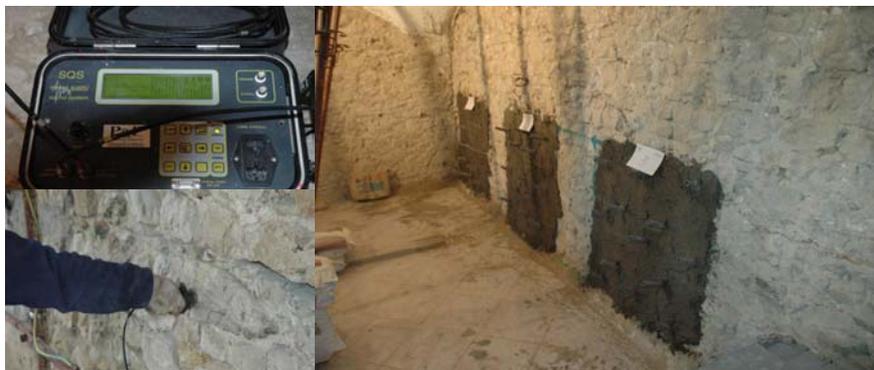
Figure 11. Sonic (left) and absorption (right) tests.

Sonic pulse velocity tests (Fig. 11), based on the generation of sonic/ultrasonic impulses at a point of the structure, are useful for different purposes, i.e. to qualify the masonry through the investigation of the wall section morphology, detect the presence of voids, and find crack and damage patterns. These tests have been performed widespread in all the Castle. In particular sonic tests have been carried out before and after absorption test to check repair effectiveness after mortar grout injections.

Absorption tests have been used to compare two different products for mortar injections, aimed to set up the main consolidation process parameters (e.g. pressure and time of the injection and number of injection holes). The tests (Fig. 11) have been performed on a representative building masonry portion. Subsequently mortar injections, sonic tests and boreholes with video endoscopy have been carried out, in order to check the quality of the consolidation process (demonstrated by a significant increase of mortar sonic velocity: 600 m/s ante injection, and 1300 m/s post injection).
